CONCRETE REMEDIATION

Surface recovery of a corroded concrete acid tank containing 17% concentrated sulphuric acid. Completed installation provided a renewed solid surface on which to install a new HDPE lining. Project completed in 8 hrs using 4 men, compared to 21 days which would have been required to construct a new tank. The CC came into contact with acid during installation but this did not affect setting or performance.

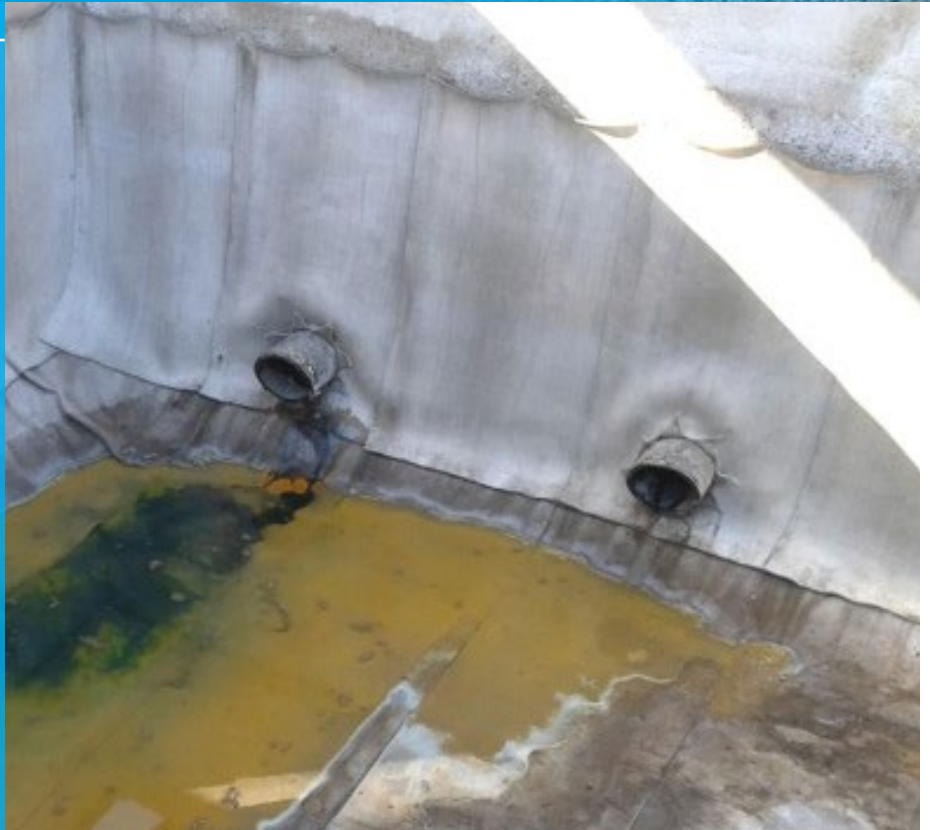
Completed lined acid tank 9 hours after hydration.

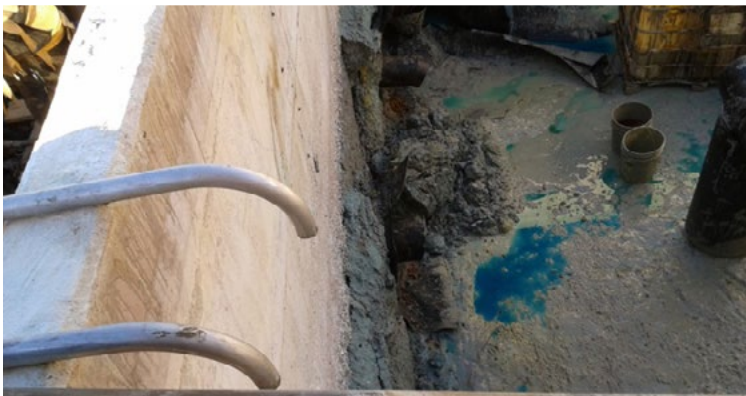
Dilapidated concrete acid tank (in disrepair due to many years of exposure)

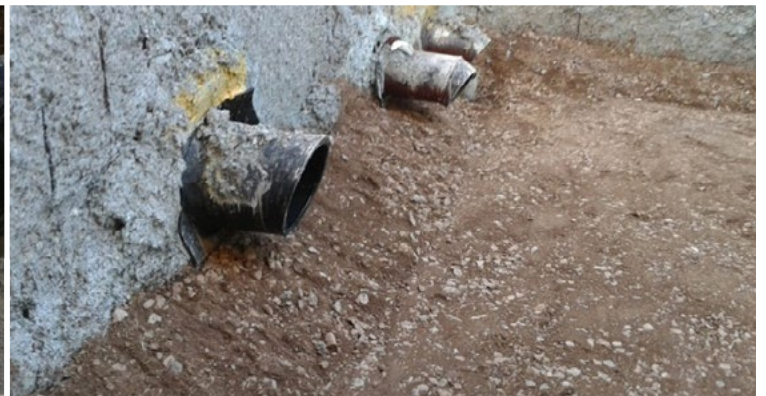
Recovering the tank ground level with graded earth

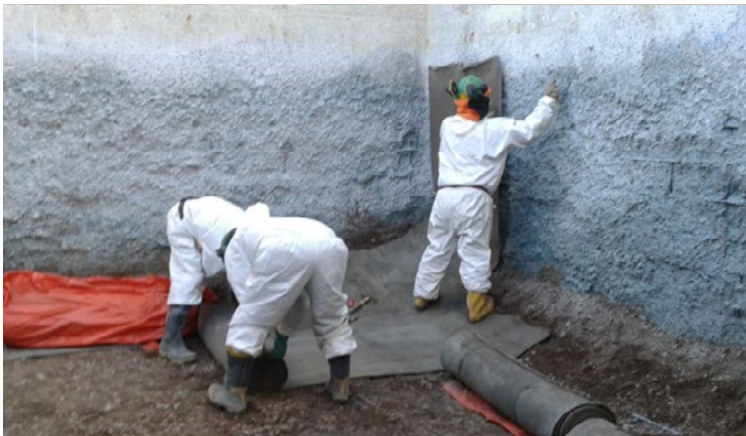
Start of CC installation (16:00hrs)

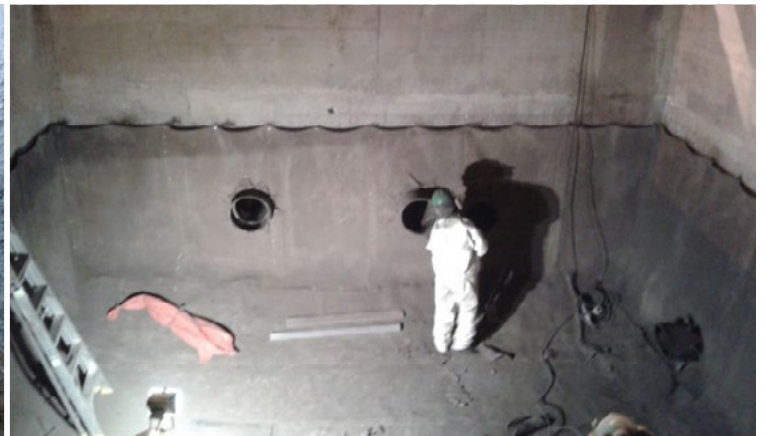
Completed installation (00:30 hrs)
