CC5 Bulk Rolls

Rustenburg, NW
Province, South
Africa

CC used to line a
50 year flood dam
in the salvage yard
of Impala Platinum
Mines in South
Africa.

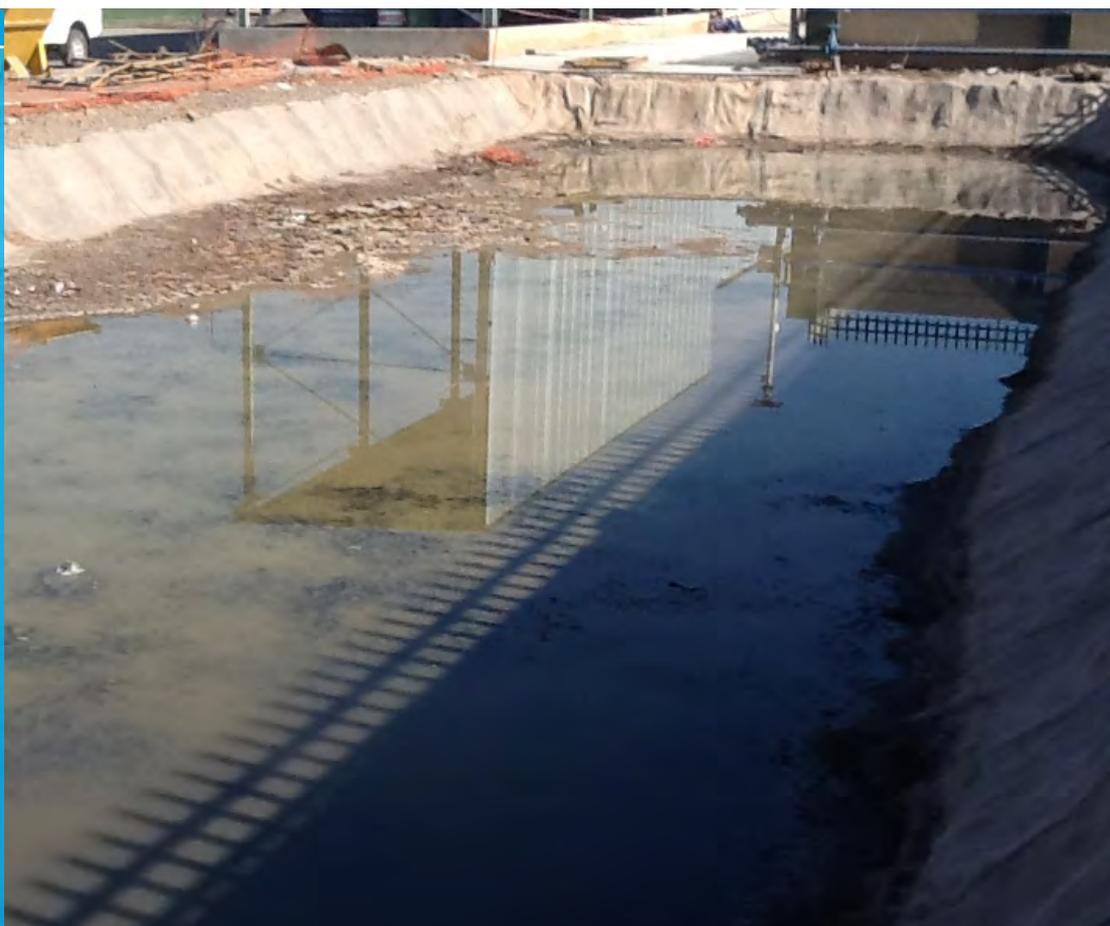
Completed dam lined with CC5

The installation was very successful. CC was able to be installed in high temperatures, (40°C+) by a team of 10 in just under two days, using basic tools and with very little training. The dam has now been in operation for over a year and has continued to operate efficiently with no leaks or failures. Impala Platinum have noted that CC was easy to handle and install, and provided a far more cost-effective alternative to traditional concrete linings.

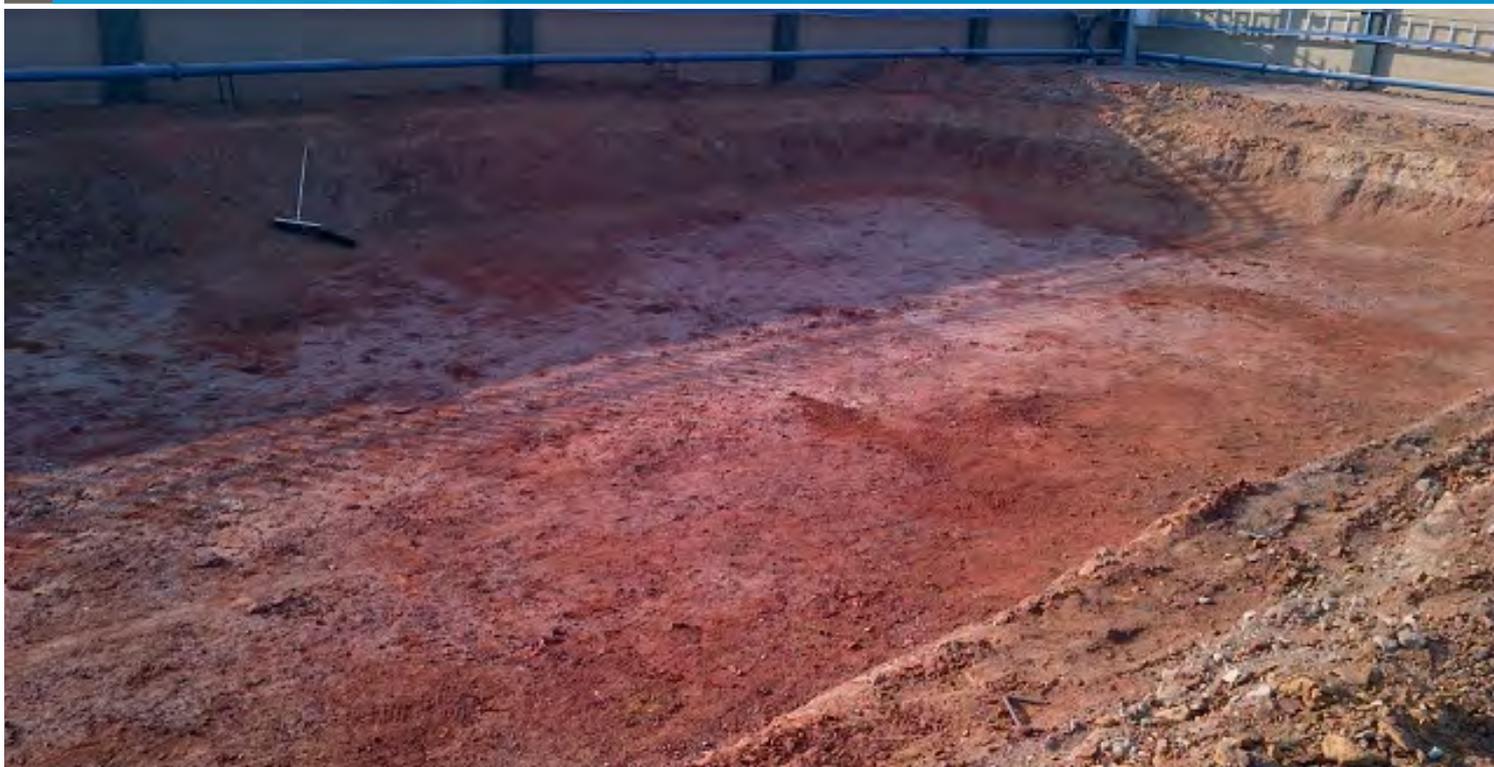
The dam site was excavated and cleared by an on-site team prior to installation of CC

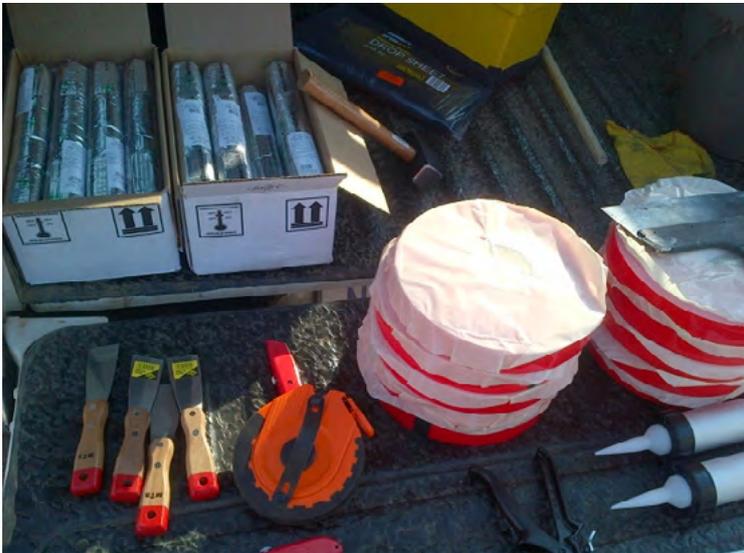
The project was completed using readily available hand tools

After the preparation team had excavated the dam, 500sqm of CC5 was supplied to the project site in bulk rolls. Basic, readily available hand tools were used on site to cut the CC to the required length, before adjacent layers of CC were taped along the joint on the impermeable side using Very High Bond (VHB) Tape. The CC sections were then laid in place in the dam, pegged along the outer edges, and the joints along the concrete side sealed with Hybriflex, (a UV-resistant, waterproof sealant.) On-site equipment was then used to hydrate the CC.

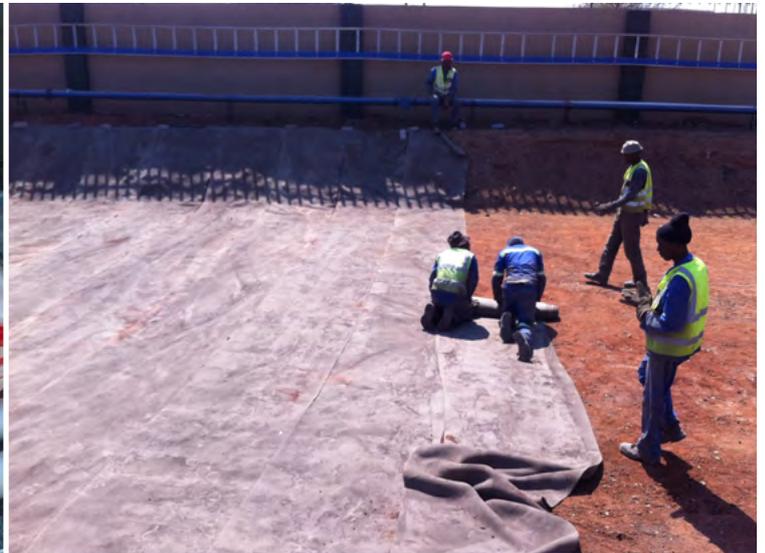
Joints between layers of CC were sealed with a VHB tape underneath

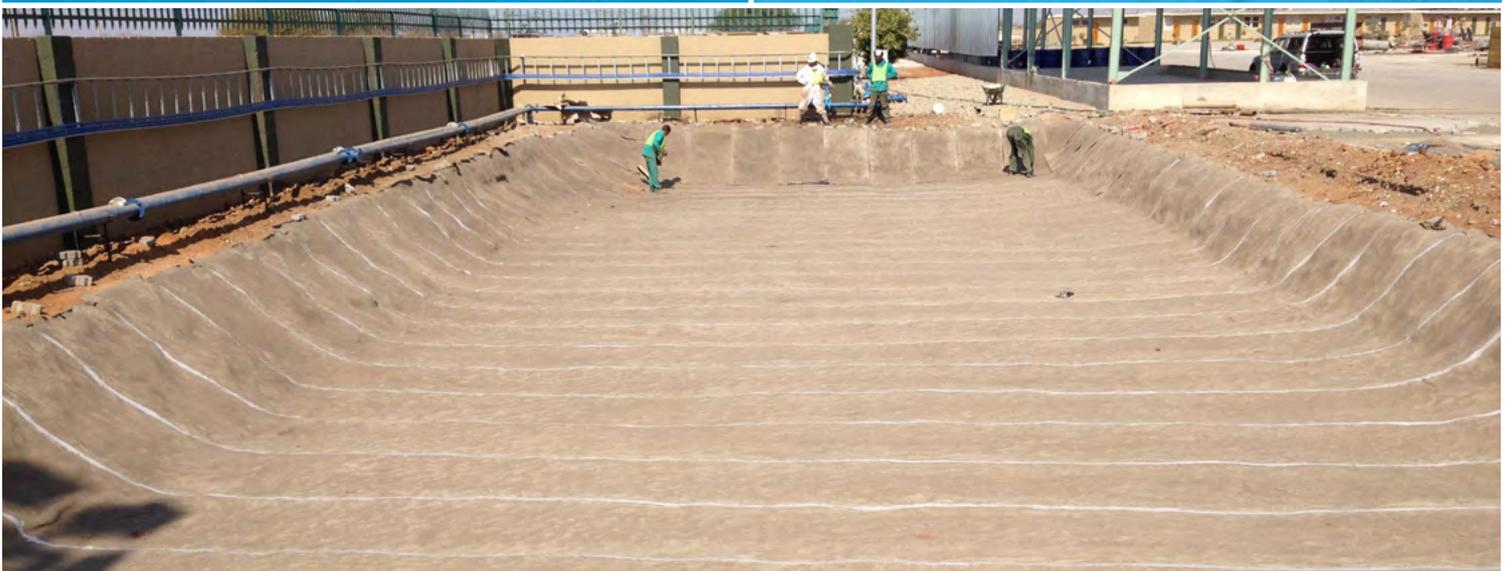
A UV-resistant, waterproof sealant was used to seal the joints on the concrete side
